# **An Analysis of Collision Mitigation Effectiveness**

## **Pre- and Post-Installation of Bird Collision Deterrents at Four Toronto Buildings**

March 30, 2018

Prepared by: FLAP Canada

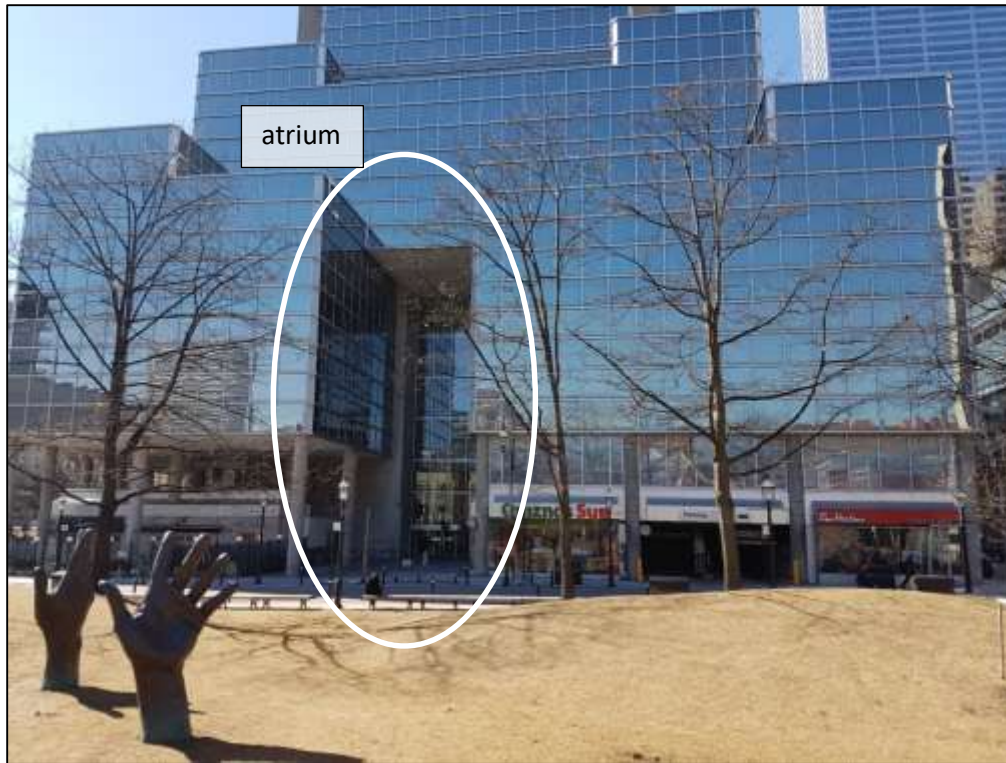
**Figure 4.** The location of the atrium at 33 Yonge Street, view from Berczy Park. *Source: FLAP Canada, 2018.*

In 2014, the atrium (**Figure 4**) was the first section of the east façade to have installed a dot-patterned bird collision deterrent window film (**Figure 5**). The property owners chose to start with this inset entranceway due to the abundance of dead birds seen by building occupants accessing the building.

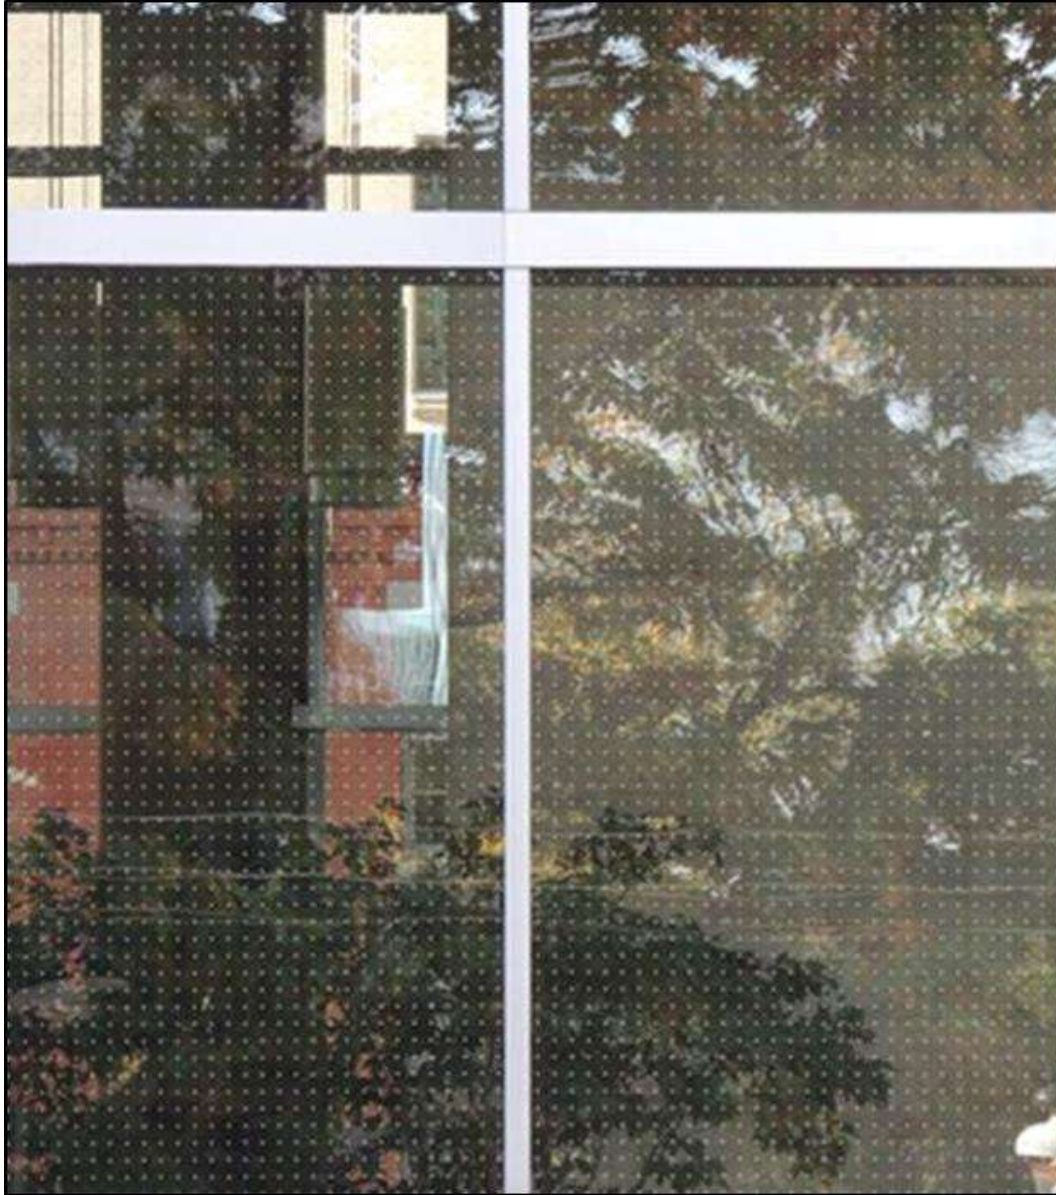
**Figure 5.** Example of a dot-patterned bird collision deterrent. Source: FLAP Canada.

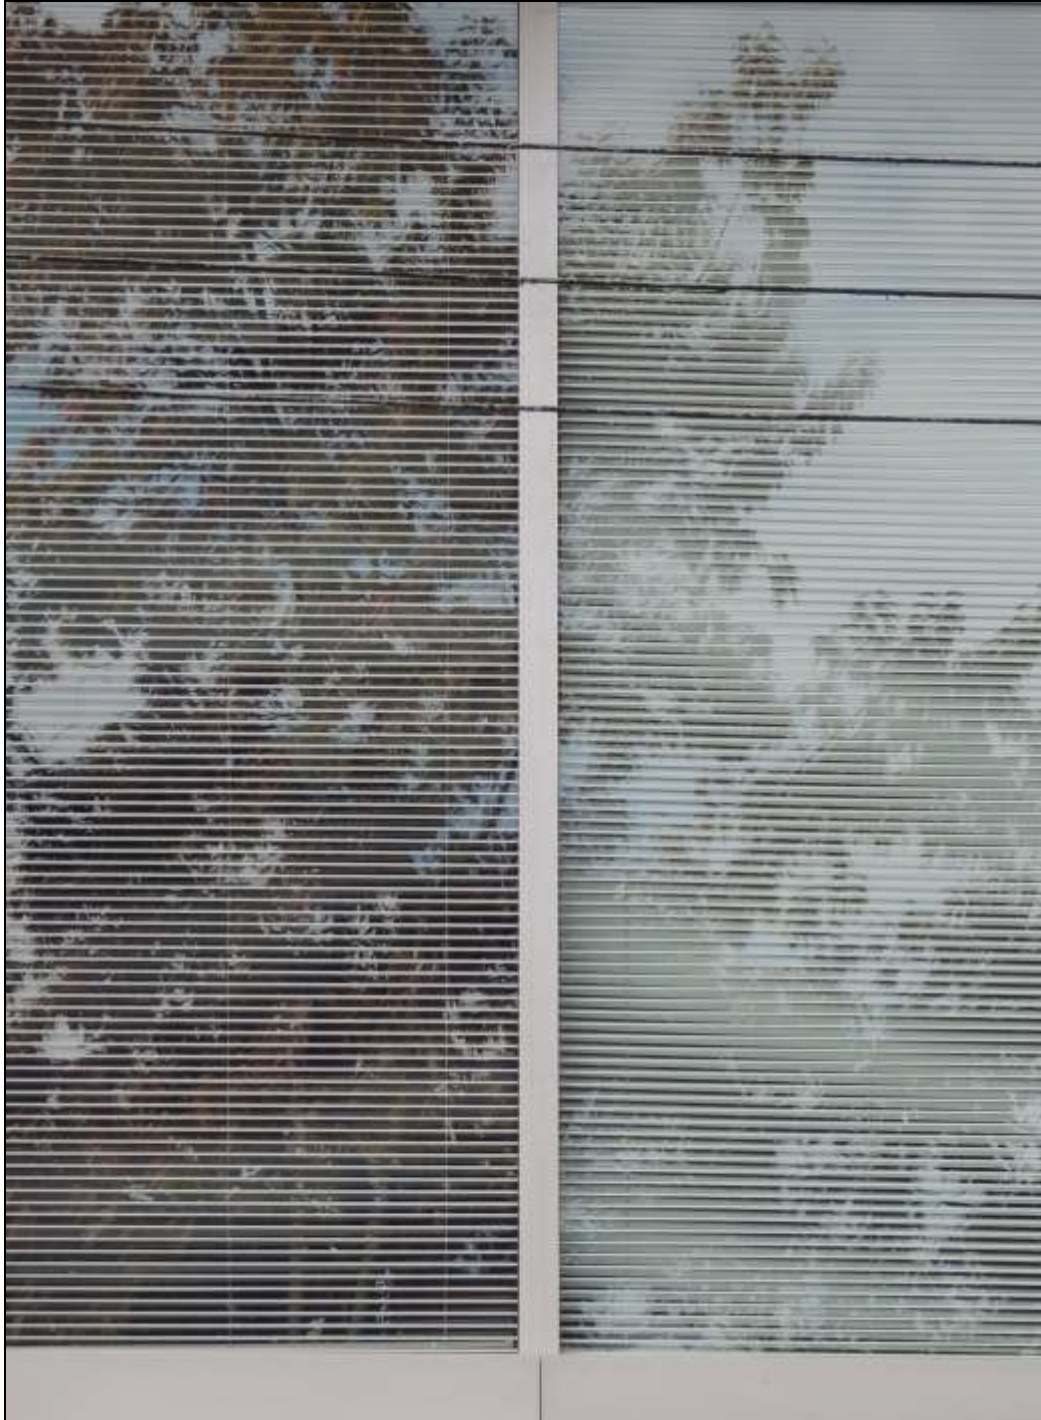
**Figure 6.** Example of a venetian patterned bird collision deterrent marker. *Source: FLAP Canada.*

In 2015, GWL then installed a venetian blind-patterned bird collision deterrent (**Figure 6**) to the remaining east-facing façades, on either side of the previously treated atrium to a height of approximately 12 metres.

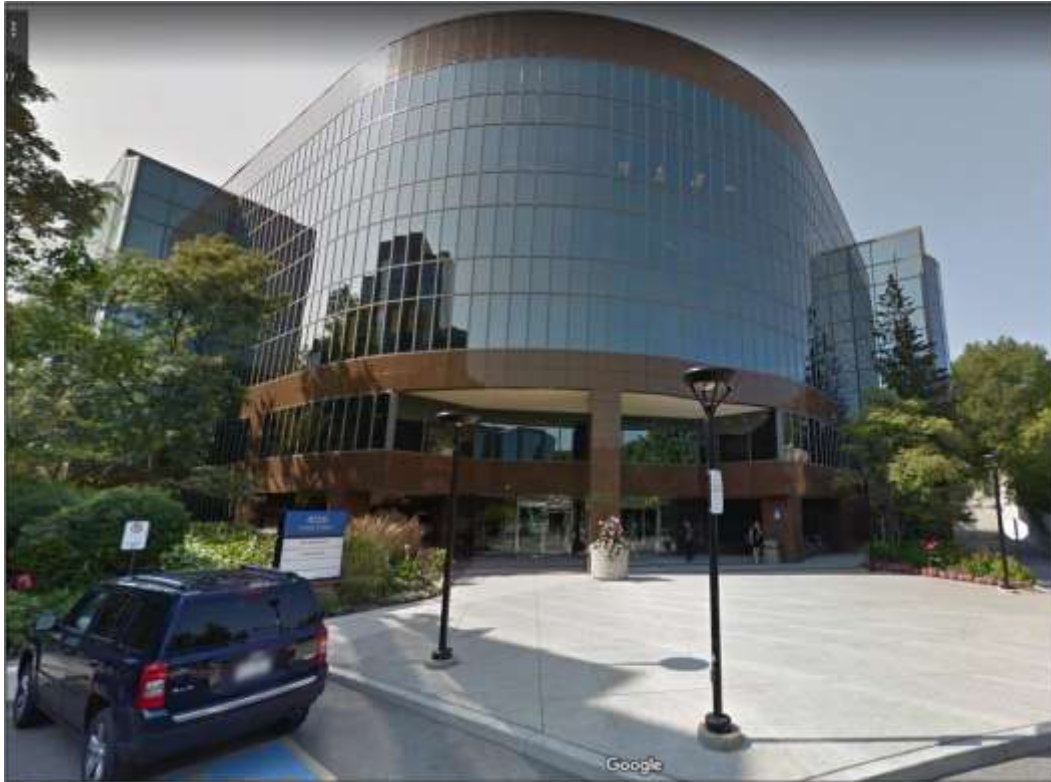
**Figure 9.** Mirrored exterior of east-facing façade at 4120 Yonge Street. *Source: Google Maps, 2018.*

The neighbouring valley lands, water courses, shrubs and grasses attract a high concentration of bird species resulting in a higher risk of exposure to collisions. The majority of 4120 Yonge Street is surrounded by this lush vegetation, which include mature trees exceeding 16 metres in height. These landscape features are situated as close as 3 metres to the building's mirrored façades. The exteriors of all three YCC buildings are clad in predominantly mirrored glass (**Figure 9** and **Figure 10**).

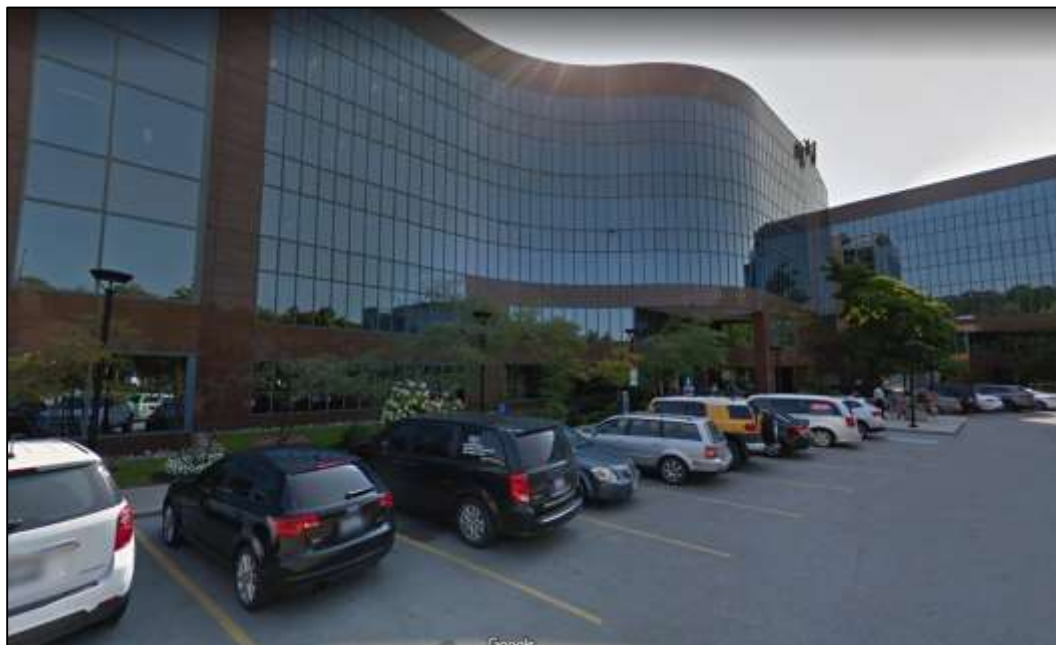
**Figure 10.** Mirrored exteriors of YYC building complex. *Source: Google Maps, 2018.*

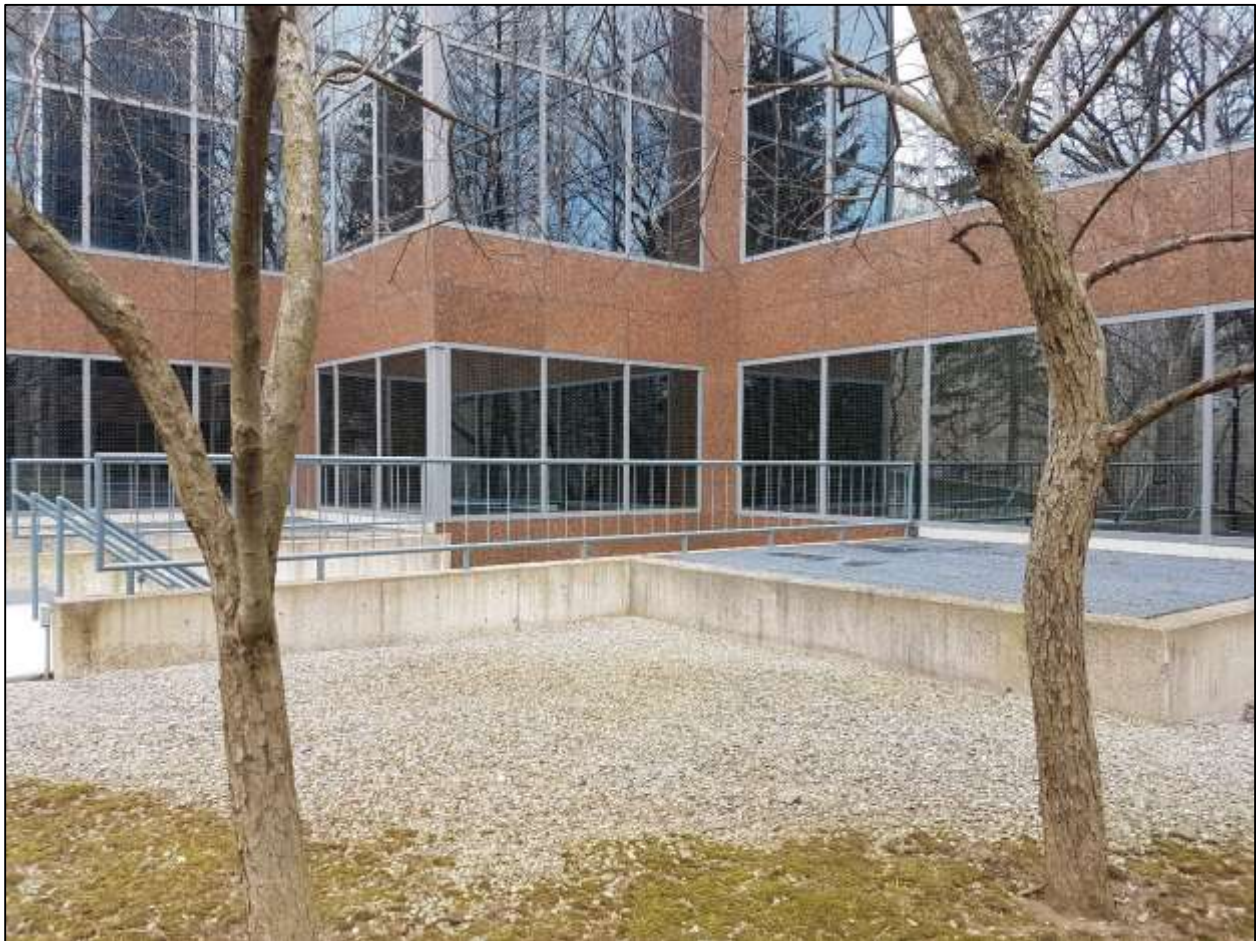
**Figure 11.** Irregular shape of the north façade of 4120 Yonge Street. Source: FLAP Canada, 2018.

Another feature of 4120 Yonge Street and YCC that contributes to bird-window collisions is the irregular shape of the buildings. As shown in **Figure 11**, the staggered glass creates an alcove effect which channels birds towards the center, enclosing them in mirrored glass and making it difficult for them to differentiate between real and reflected images in order to escape.

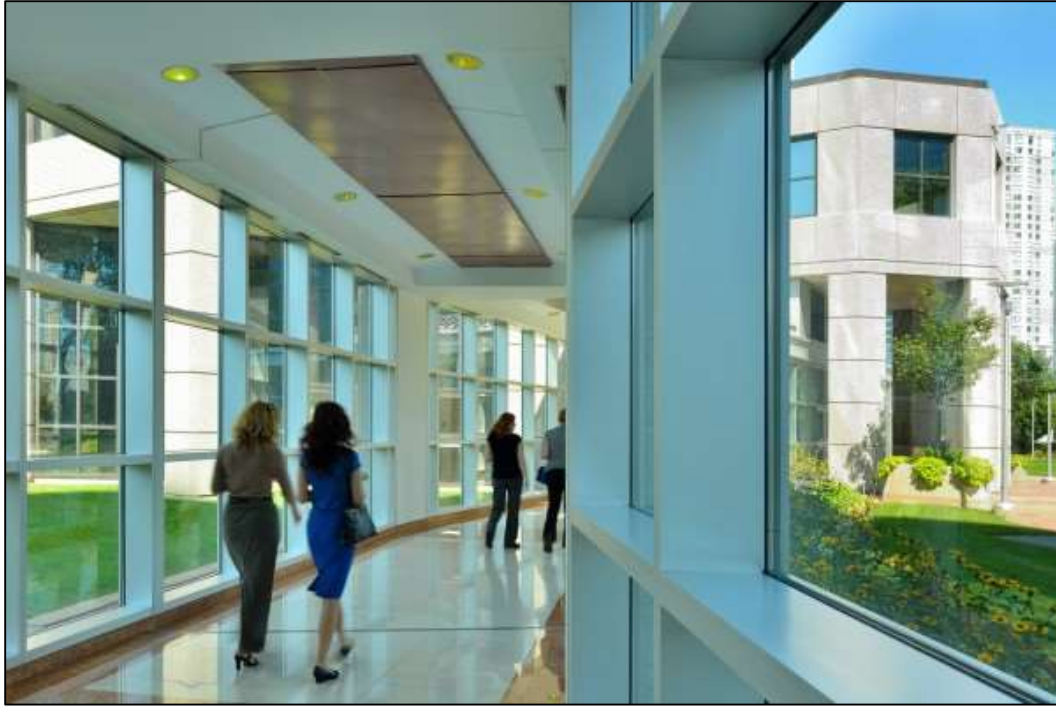
**Figure 15.** Glass linkway between 200 and 300 Consilium Place. *Source: Consilium Place, 2018.*

Both 100 and 200 Consilium Place share identical building profiles and are enclosed by some of the most highly-reflective mirrored glass on the market. Over a period of twelve years (2006 to 2017), FLAP Canada documented a total of 3,525 collisions with 2,334 representing bird fatalities at 100 and 200 Consilium Place. These two buildings at Consilium Place are surrounded by vegetation and fully covered in mirrored glass. The exterior of 300 Consilium Place has some stone cladding. An all-glass linkway (**Figure 15**) bridges the pedestrian corridor between 100 and 300 Consilium Place while the pedestrian corridor constructed between 100 and 200 Consilium is a transparent glass atrium (**Figure 16**).

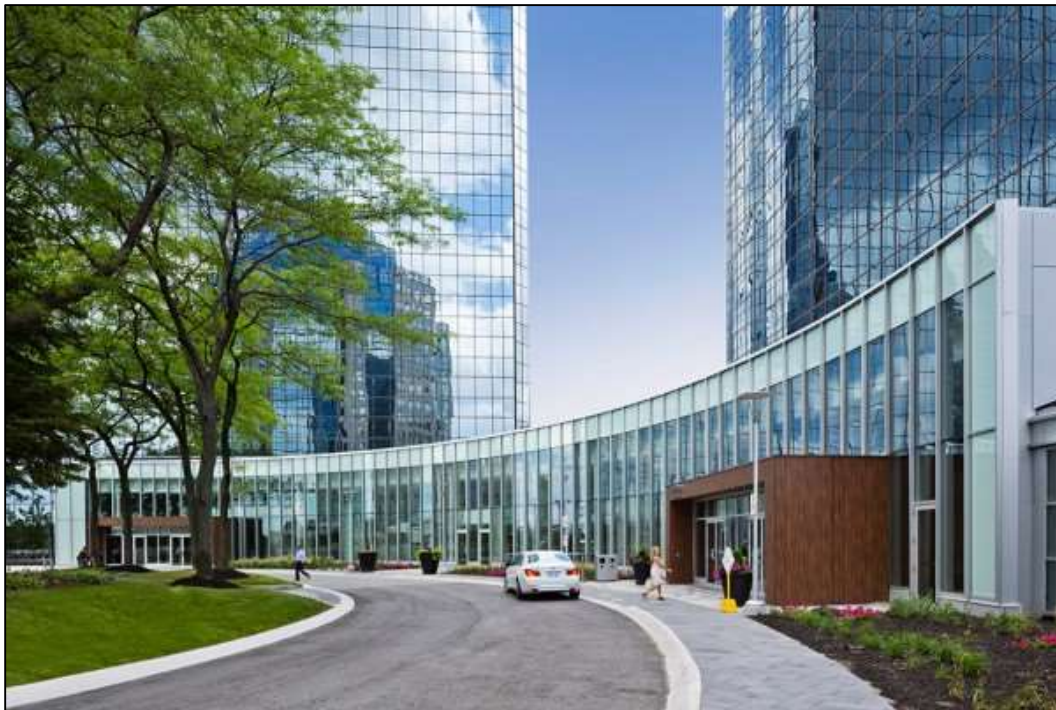
**Figure 16.** The atrium between 100 and 200 Consilium Place. *Source: Consilium Place, 2018.*

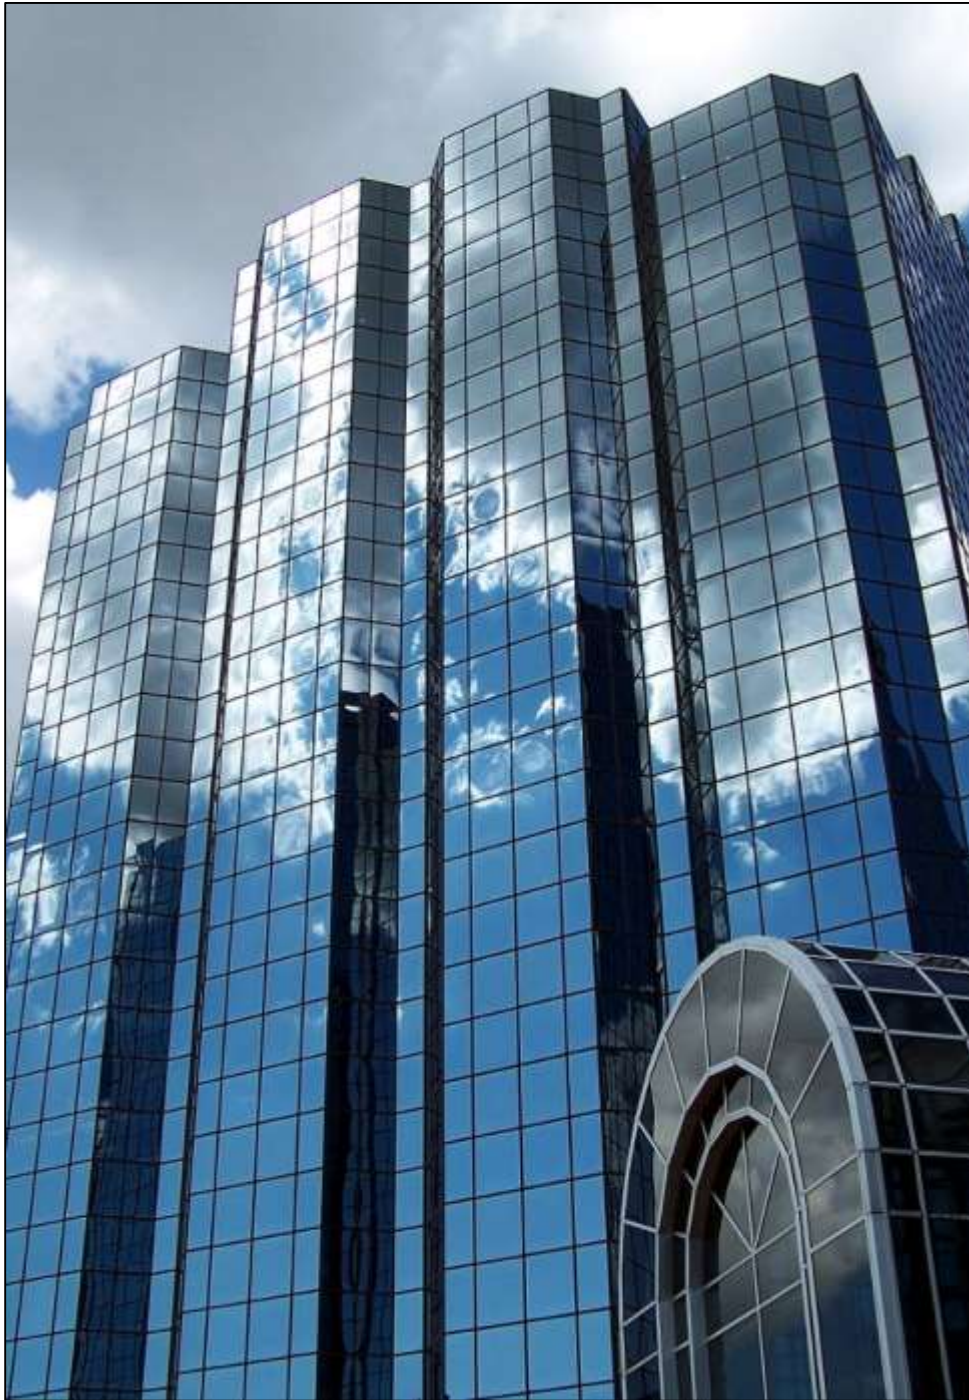
**Figure 17.** View of the mirrored exterior at 100 Consilium Place, looking south. Source: FLAP Canada.

The building at 100 Consilium Place (**Figure 17**) is located in the southwest quadrant of the complex. The majority of bird-window collision reports for this building were on the northwest, southwest and southeast façades as the majority of bird bodies on the northeast façade fall onto the lobby rooftop, which is inaccessible to FLAP volunteers.

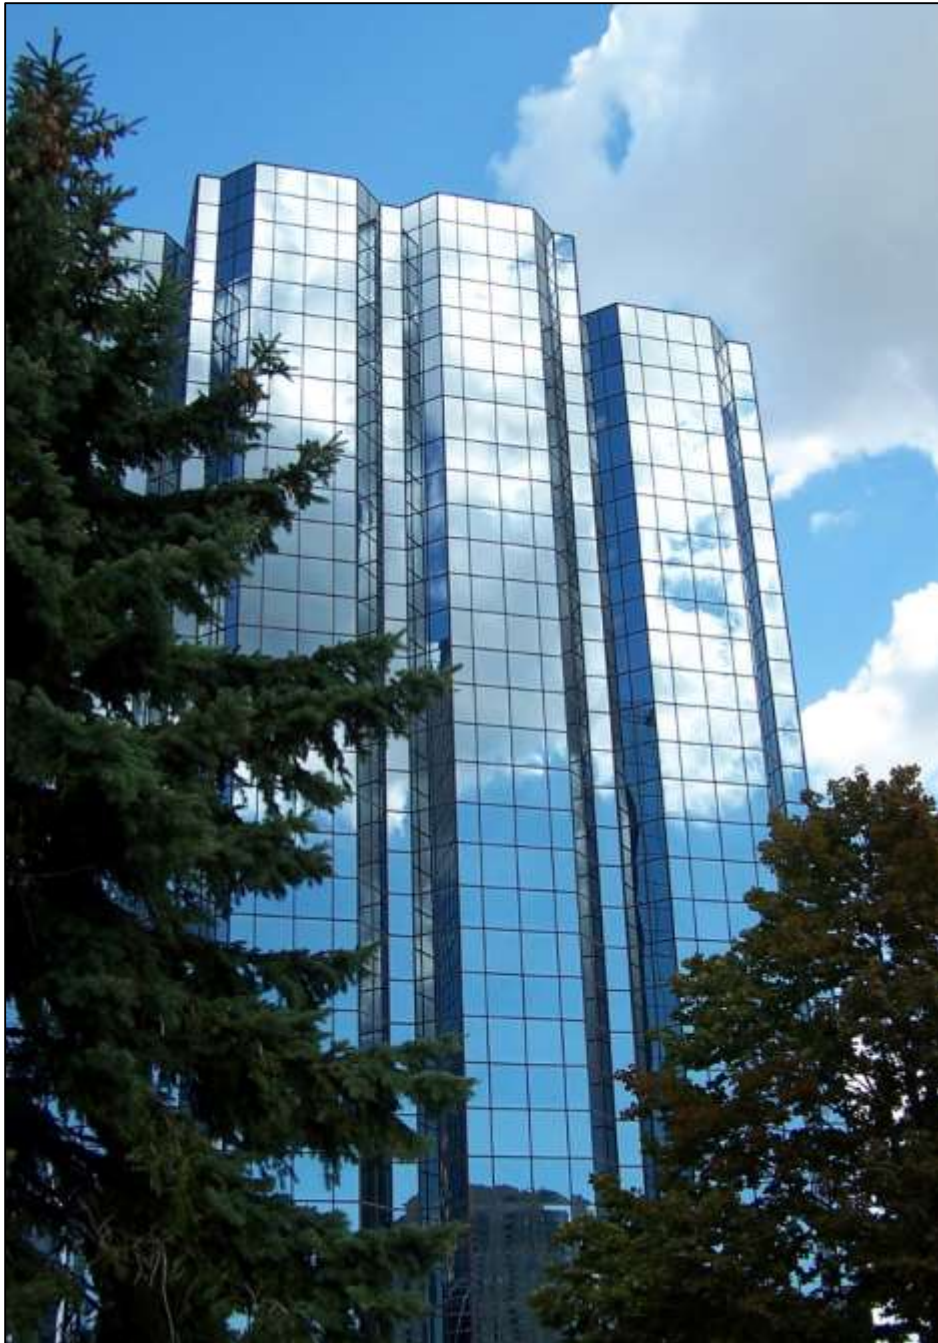
**Figure 18.** Mirrored exterior and trees at 200 Consilium Place, looking northwest. Source: FLAP Canada.

To the east of 100 Consilium Place and joined by the all-glass atrium is 200 Consilium Place (**Figure 18**). It replicates the profile and aesthetic of 100 Consilium with its mirrored exterior. The majority of bird-window collision records for 200 Consilium Place were for the northeast and southwest façades. Data was not readily available for the northwest façade because the same lobby rooftop as 100 Consilium Place was likely preventing birds from reaching the ground. The southeast façade has lower collisions records than the other sides as there is minimal vegetation surrounding the facade.

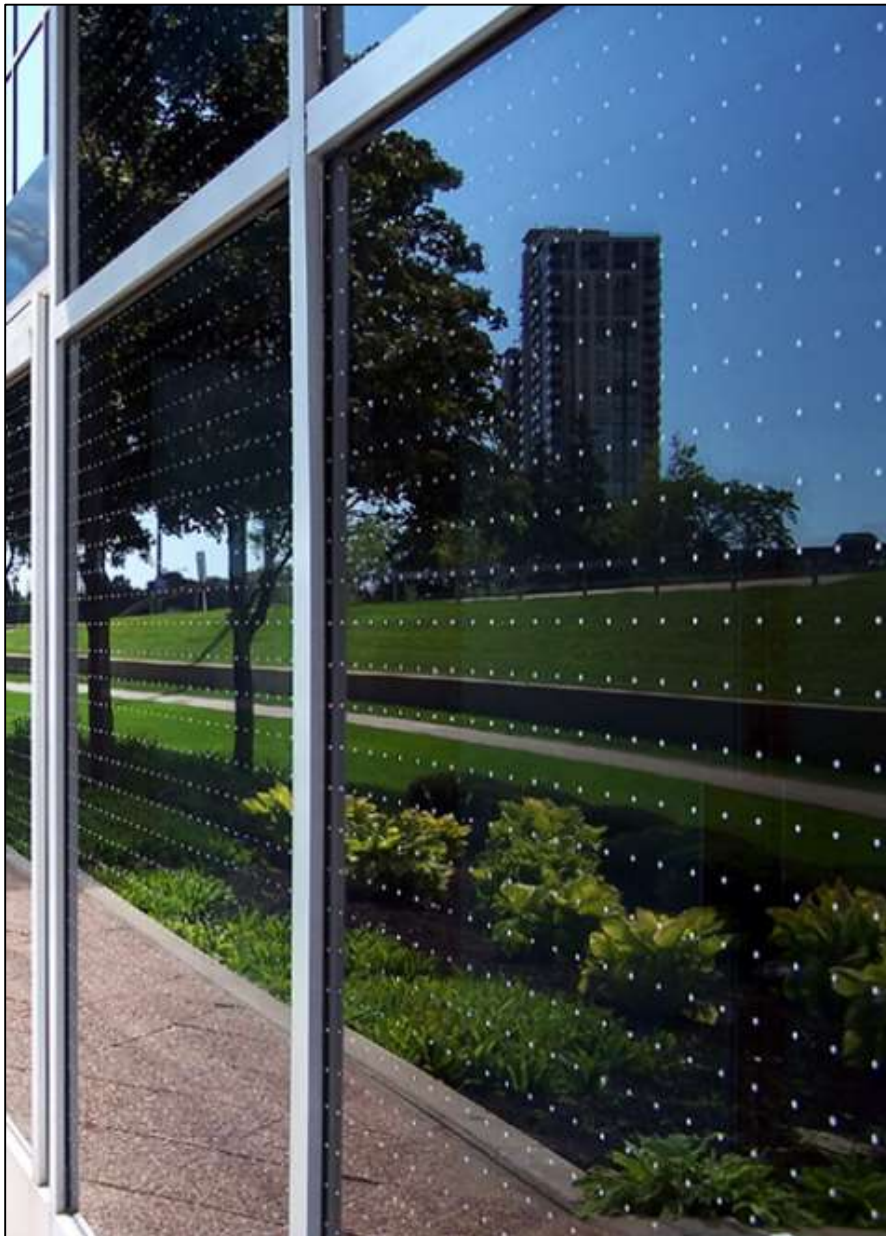
**Figure 19:** Southwest Façade of 100 Consilium Place, *Source: FLAP Canada.*

During the trial, *Shultz v. Menkes Developments, 2012*, in an effort to demonstrate due diligence to the courts, while at the same time prepare the property for sale, the building owners collaborated with FLAP Canada and a window film contractor to develop a first-of-its-kind test application of a bird collision deterrent for a commercial structure. This test application used an adhesive film with a pattern of 4 mm grey dots spaced 5 cm vertical X 5 cm horizontal to cover the first surface of the windows on the southwest façade of 100 Consilium Place (**Figure 19**) to a height of 16 metres above grade.
